अध्यक्ष, राष्ट्रीय बांध सुरक्षा प्राधिकरण
जल संसाधन, नदी विकास और गंगा संरक्षण विभाग
जल शक्ति मंत्रालय, भारत सरकार
आठवाँ तल (उ), सेवा भवन, आर के पुरम, नई दिल्ली- 110066
Chairman, National Dam Safety Authority (NDSA)
Department of Water Resources, River Development and
Ganga Rejuvenation, Ministry of Jal Shakti, Govt. of India
Telephone: 011- 20861658

D.O.No. TE-32/5/2024-NDSA-MOWR/11

Dated.: 01.05.2024

RECOMMENDATIONS ON THE INTERIM MEASURES AND FURTHER STUDIES/INVESTIGATIONS TO BE TAKEN UP BY IRRIGATION & CAD DEPARTMENT, BEFORE THE ONSET OF COMING MONSOON

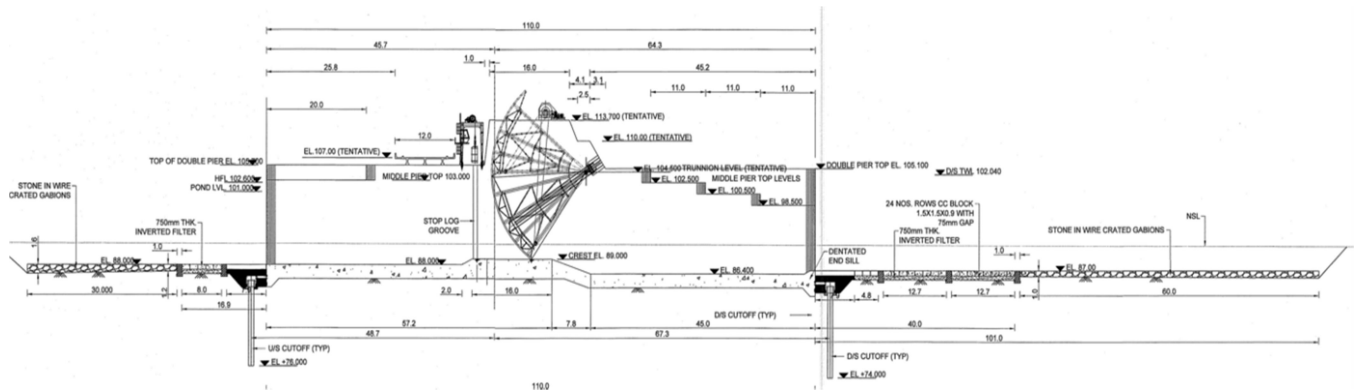
Fig.-1 Longitudinal sectional details of Medigadda (Laxmi) barrage

The barrage structure is 1632 m long and 20.1 m in height. The length of the barrage is divided into 8 blocks. As reported to the Committee, on 21st October 2023, at around 6.20 pm, sinking of road bridge panels and parapet wall in Block No-7 was noticed with loud sound heard up to control room located about one km. The visiting inspection team from I&CAD on 22.10.2023, besides the structural damages to the pier, have also reported a slow whirling action of water upstream of Pier no 20, two sand boils on downstream side of Block-

7 in the bays between Pier nos 16 and 17 and between Pier nos 17 and 18. The stored water from the barrage was immediately released downstream.

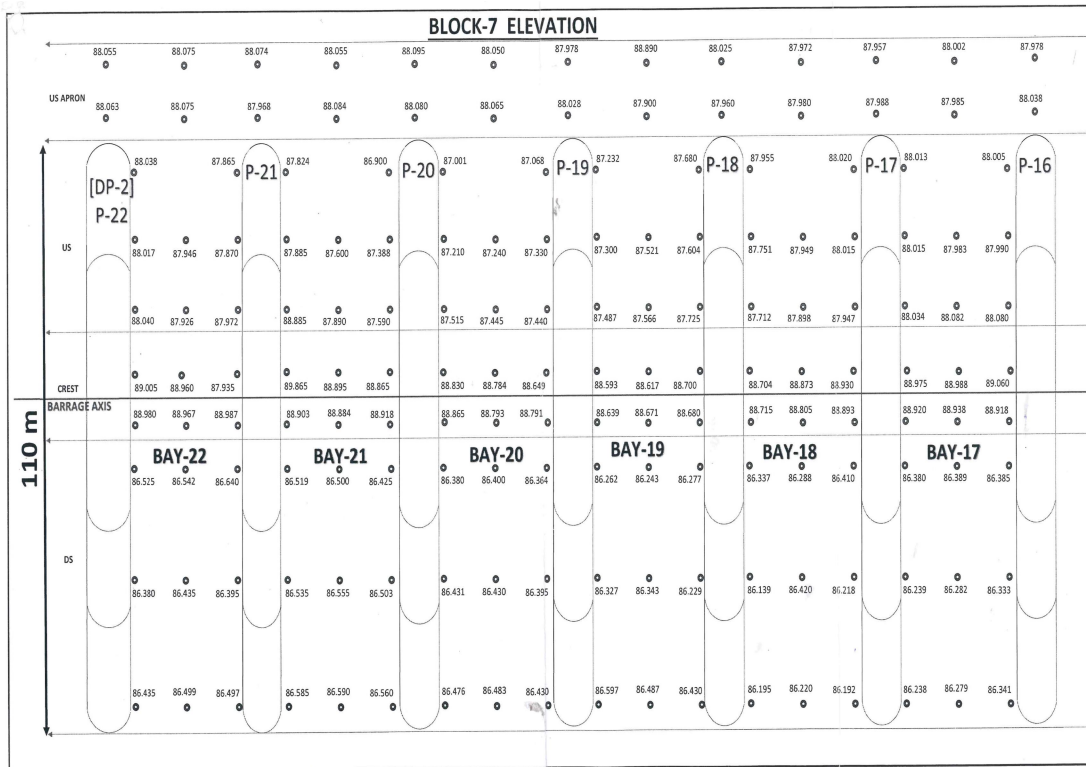
Fig.-2 Measured levels after the sinking of raft of Block No. -7

Block No. 7 of the barrage comprises of Pier nos. 11 to 22. The Pier nos. 16 to 21 have undergone settlement to varying depths, and tilting to varying degrees. Cracks have developed in these piers and raft floor of Block-7. The settlement of the piers along with the raft is decreasing from upstream end to downstream in all the piers. The Pier no 20 at its upstream end along with the raft has settled by over 1.2 m. Wide structural crack has developed in pier 20, visibly ranging from a width of around 70 mm near gate crest to around 300 mm at the pier top, extending from the junction of pier and raft to the top of pier, traversing along the upstream periphery of the guide rail of the radial gate at Pier no 20. The reinforcements along the crack for full height of pier have failed. Cracks have developed in the piers on the downstream of the radial gate as well. Structural cracks are also noticed in the adjacent piers. Gantry girder and gantry rail alignment is distorted in horizontal direction in few of the piers. Welding joints between the two gantry girders over pier are distorted. The measured levels after sinking of raft and upstream plinth slab of block no.-7 is shown at Fig.-2, which points to the fact that the magnitude of the settlement failure in Block No -7 is quite extensive.

1. The following activities/measures shall be carried out in the given sequence below for Block No.-7:
 - a. Crack monitoring at appropriate locations shall be carried out to an accuracy of +/- 1.0 mm, through appropriate techniques such as tell-tales etc., for continuous monitoring of the movement across all the cracks in piers and raft floor.

- b. Pier nos. 16 to 22 have either tilted or have developed cracks to varying magnitude. These piers shall be adequately braced at appropriate locations with suitable bracing system. Lattice girder/truss or box girder can also be used to arrest any likely lateral movement. While doing so, adequate precautions shall be taken that no heavy loads are transferred on to the raft.

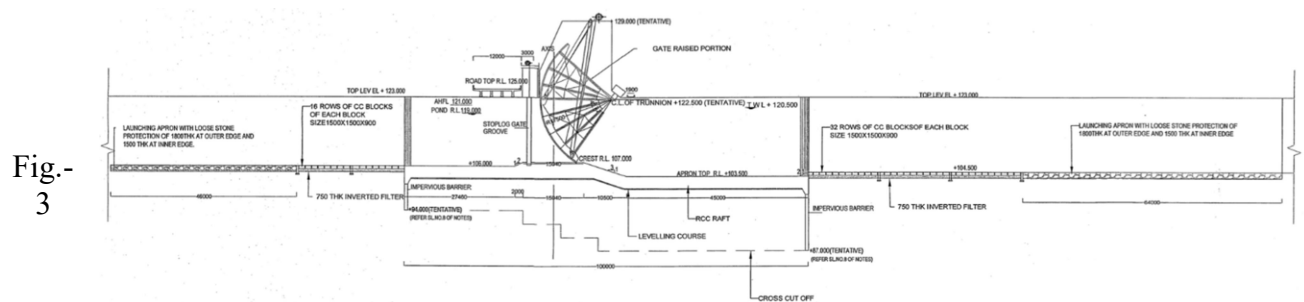
Longitudinal sectional details of Annaram (Saraswathi) barrage

During the visit, the CC blocks and launching apron at the downstream were seen damaged / settled / displaced for almost entire length of barrage. The wearing coat in the barrage sill / glacis / stilling basin was seen dislodged, damaged and washed away in several bays. Huge sand heaps were seen accumulated upstream in front of the barrage bay raft, for almost the entire length of the barrage. Hence the upstream areas of the barrage could not be inspected.

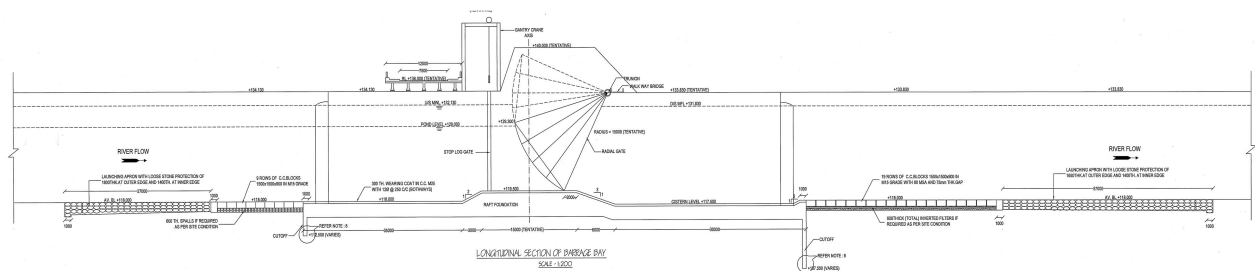
Fig.-4 Longitudinal sectional details of Sundilla (Parvathi) barrage

During the visit, the CC blocks and launching apron at the downstream were seen damaged / settled / displaced for almost entire length of the barrage.
